# **Infrared Inspections on Electric Panels without Removing Covers: Can the Inspection be Completed Correctly?**

*Joe Gierlach Director Technical Training and Support TEGG Corporation  
Joe DeMonte Senior Thermography Course Instructor*

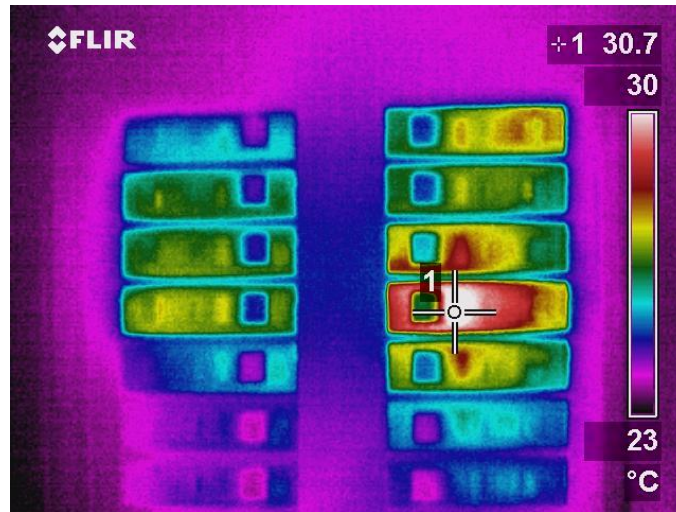
FIGURE #1

As you can see in figure #1 prior to the removal of the dead front cover, there is an obvious load on the suspect breaker 4<sup>th</sup> down on the right.

The observed temperature is around 30 degrees C and within manufacturer operating specifications. The temperature on the dead front cover is closer to 23 degrees C and not an apparent concern, right? One may simply deduce this is only load created energy on the breaker and bypass it during an inspection.

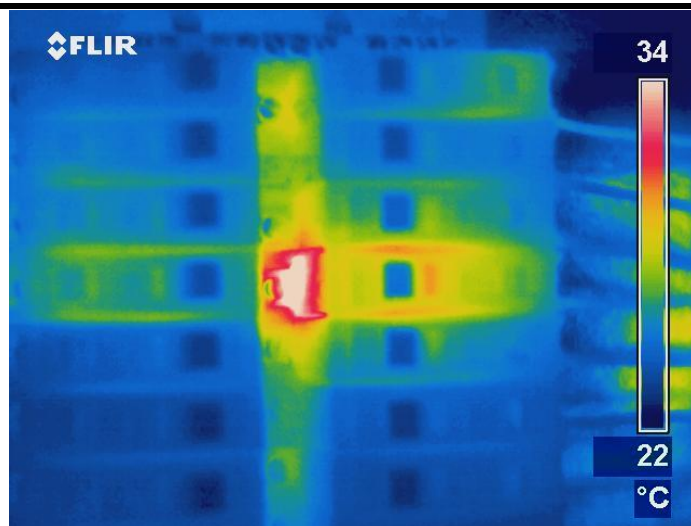
FIGURE #2

Once the cover is removed, a far worse issue is revealed in Figure #2

- The problem area centered on the line side connection.
- The actual problem temperature at this light load was approximately 39 degrees C
- This is an error or nearly 9 degrees C
- Absent removal of the cover, this more than likely would have been bypassed
- Any addition of loads would increase the problem temperature exponentially

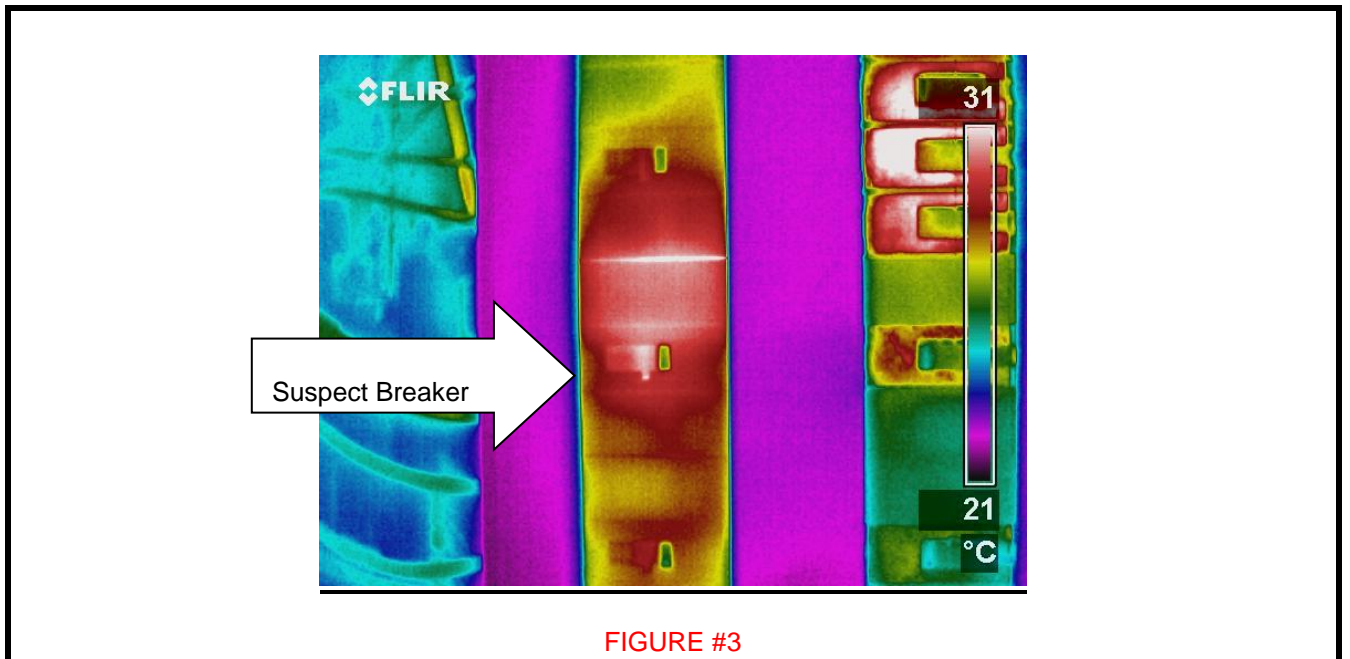
- Again, a lightly loaded breaker compared to the rating
- Around 32 Degrees C on the breaker case and well within Manufacturer Specifications for rise over ambient
- No apparent “deficiency” observed related to temperature on the dead front cover and operating around 22 degrees C by viewing the thermal image in figure #3
- But when the cover is removed, a different story is uncovered as is shown in figure #4...
- As seen below in Figure #4, the actual problem area again is the bus connection to the breaker
- But unlike the 22 degree C observed on the dead front cover, the problem temperature is now running closer to 43 degrees C
- This is an error of nearly 22 degrees C

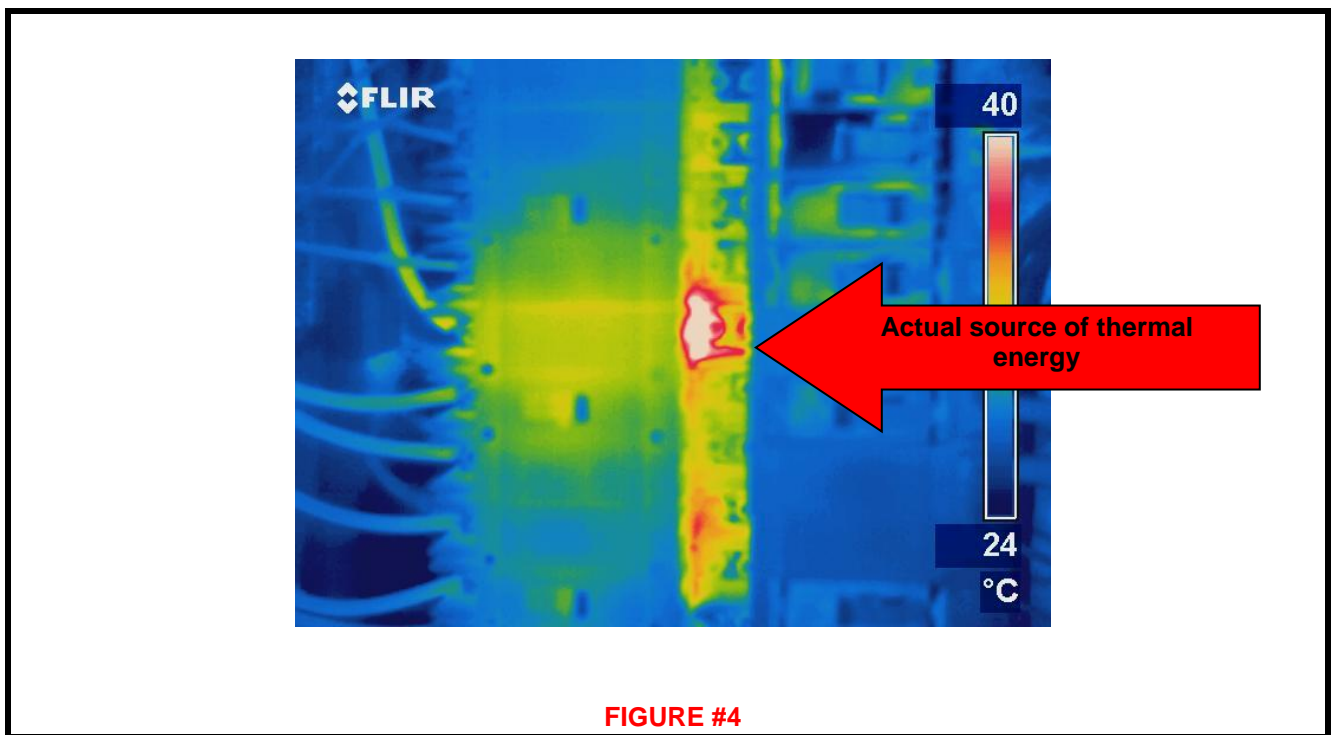
Again, with load demand being light at the time of the survey, increases must be considered and the consequences thereof. This is another clear example of how temperature errors by improper procedure of the technology for the electrical application can occur.

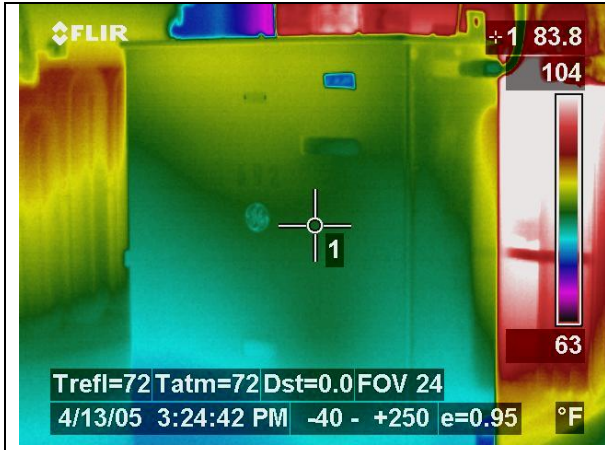
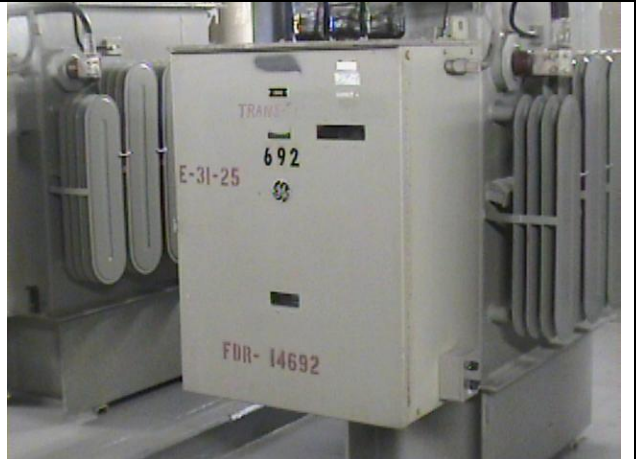
**FIGURE #5: Cabinet 692**

Consider the infrared and visual images shown in figures #5 and #6. Both show the 480V buss cabinet and connections associated with a 13.2KV to 480V step down transformer. The cabinet in figure #5 is running approximately 2°F warmer and shows considerable heat towards the top of the cabinet due to convective gains. This would seem to point to a potential issue in the 692 cabinet and no issue in the 691 cabinet. However, upon removal of each of the covers by approved safety measures, we scan with the IR camera again and find the images to be opposite of what we originally thought.

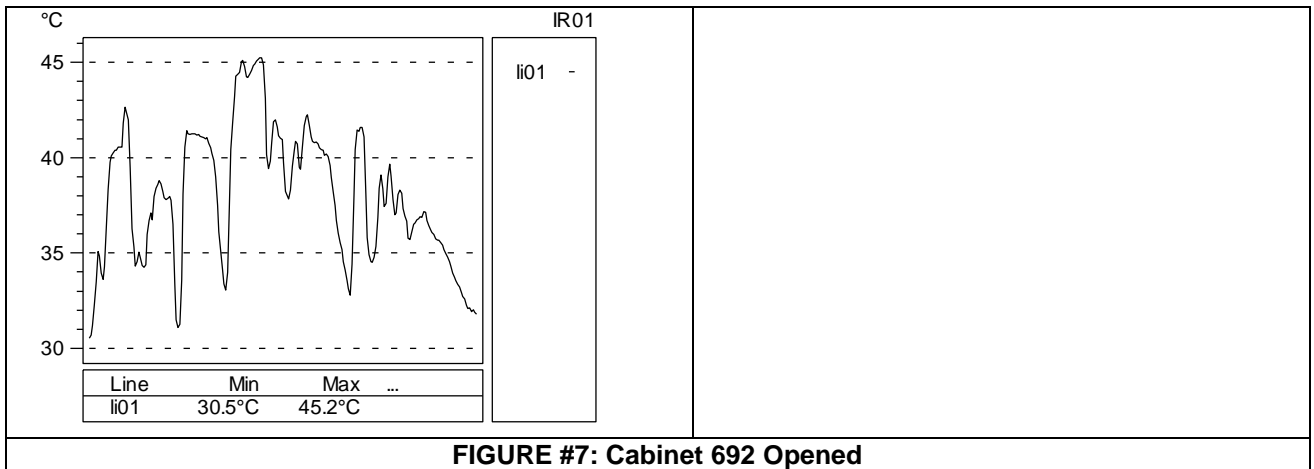
**FIGURE #7: Cabinet 692 Opened**

The cause of the heat on the warmer 692 cabinet was load related. Cabinet 691 actually had an anomaly that would have gone undetected by not properly removing the cover during the inspection. Also, the fact that this anomaly was found at approximately 10% of the system's rated load shows how a fairly important problem could have been overlooked. Once the load is increased, the heat generated by the fault will increase exponentially. Our calculations would have this rise increase to approximately 110°C when the transformer was under 80% load.

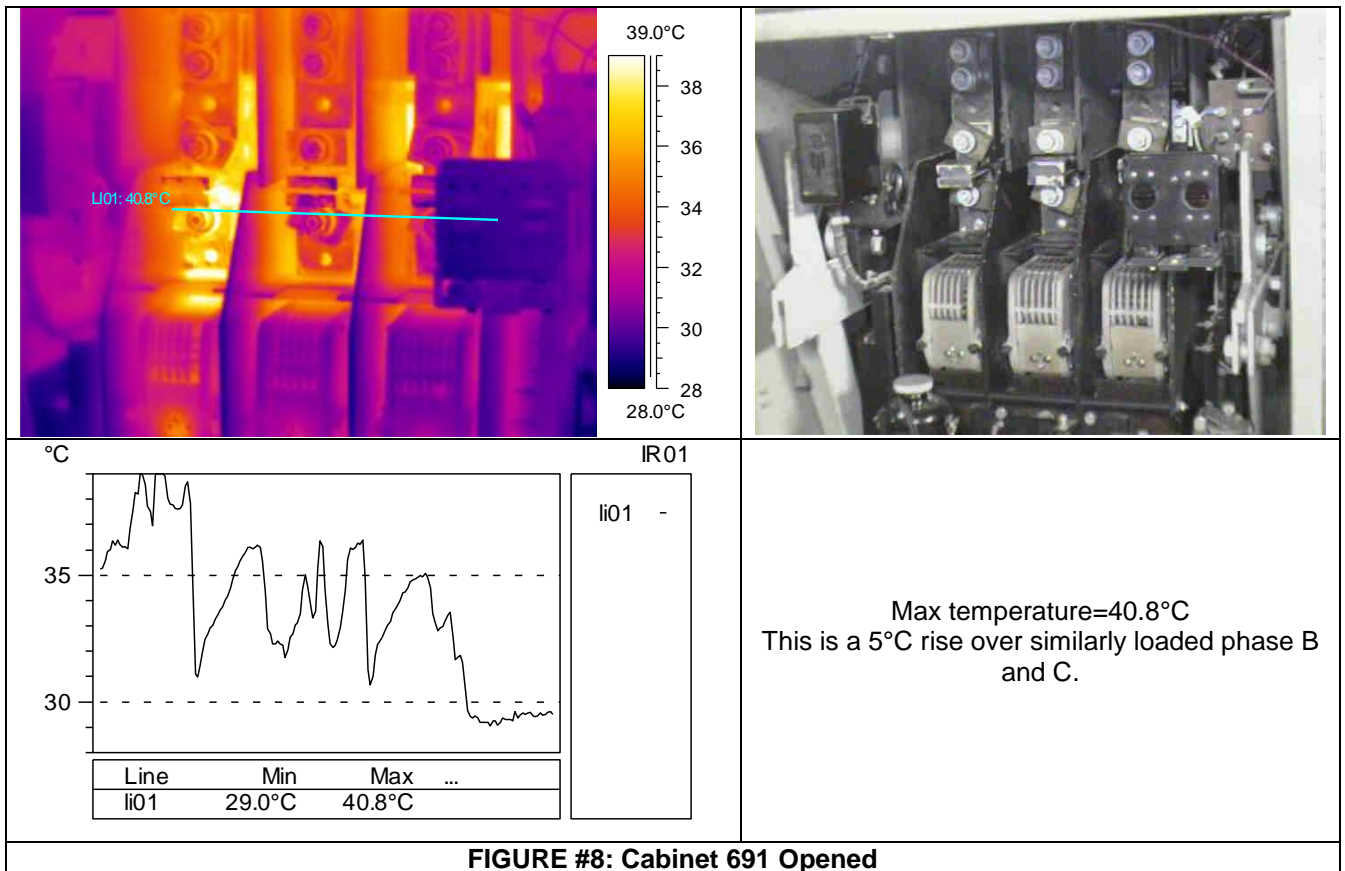
**FIGURE #8: Cabinet 691 Opened**

Max temperature=40.8°C  
 This is a 5°C rise over similarly loaded phase B and C.

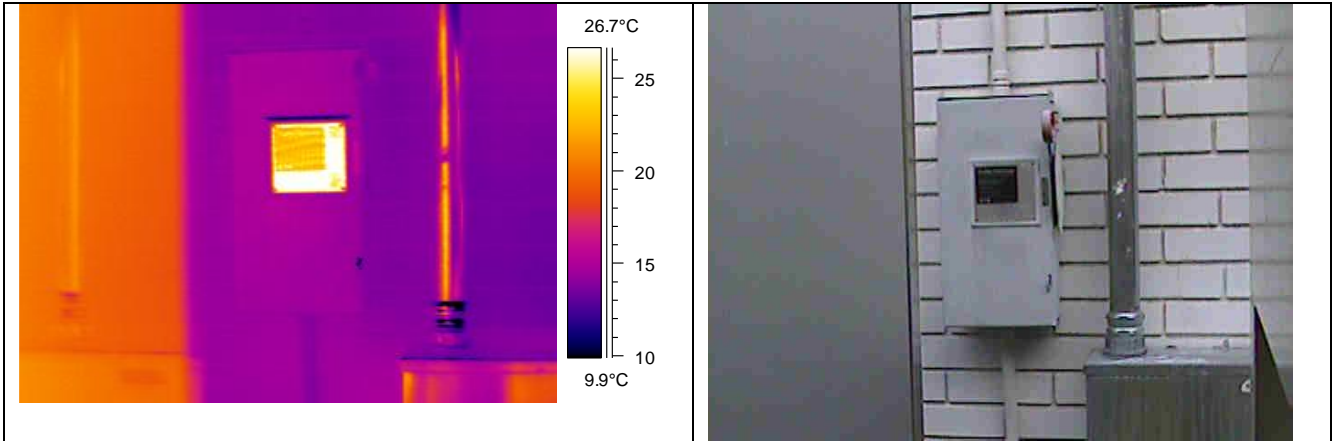
**FIGURE #9: 480V Main Disconnect**

Our next example is of a 480V main disconnect on the outside of a customer's business. As I pointed out earlier in this paper, we took IR images from the outside of the cabinet prior to opening it. Figure #9 shows both the visible and IR images of the cabinet.

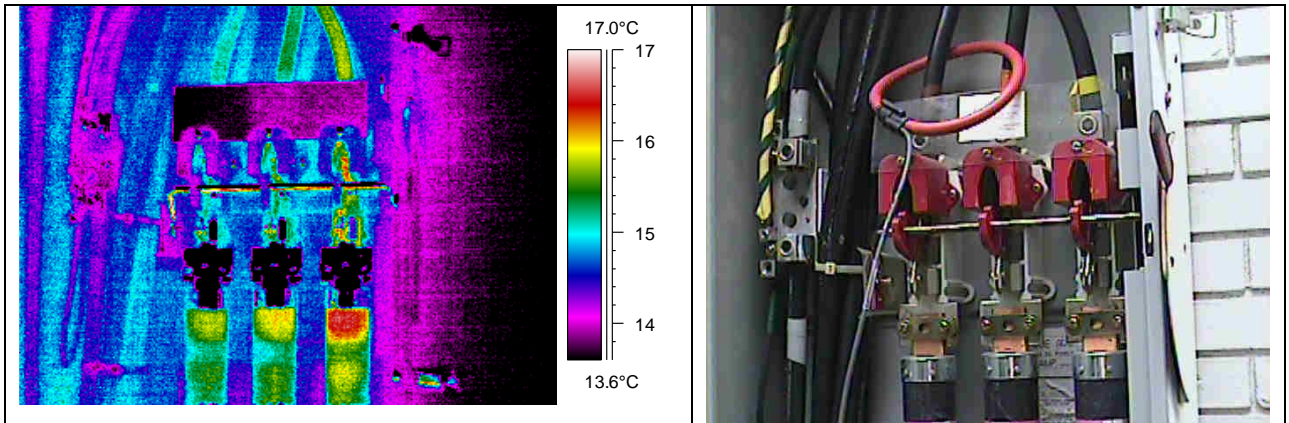
**FIGURE #10: 480V Fused Disconnect**

No issues were noted from the outside inspection. We then opened the cabinet using approved safety procedures and scanned the internal fused disconnect to look for suspicious hot spots. The problem would have been missed! Refer to Figure #10 for an infrared image clearly showing a problem on the C phase incoming connection. We needed to open this cover in order to identify it. The C-phase fuse was in need of replacement, so the recommended action was to replace all three with new fuses.

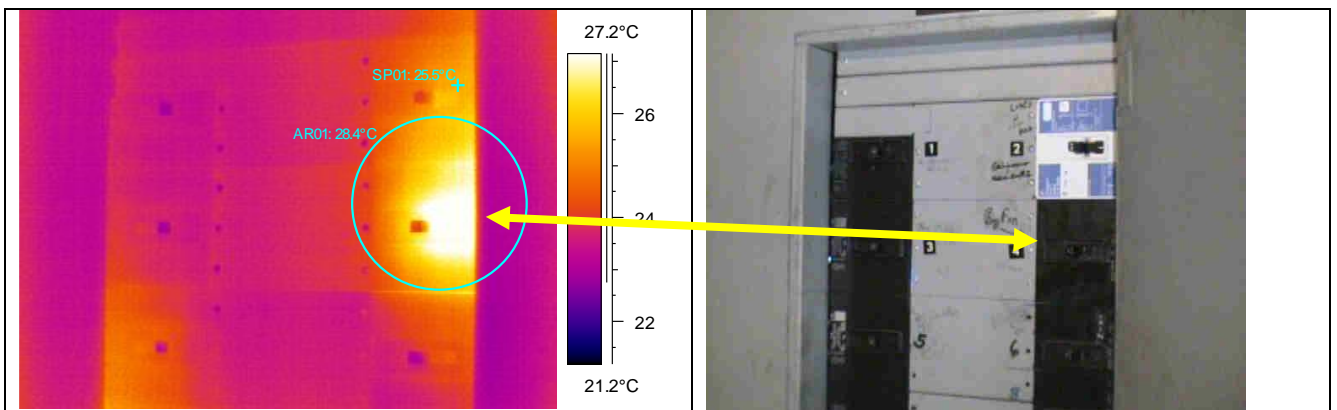
**FIGURE #11: 480V Breaker #4**

Our last example in this paper is a medium voltage breaker with the dead front cover still in place. We have a minor temperature rise of about 3°C shown on breaker #4 (see figure #11).

This infrared image shows that the breaker is a little warm, but not warm enough to warrant further investigation, right? We pulled the dead front cover, again following all safety regs, to see if there was anything worth reporting to our important customer.

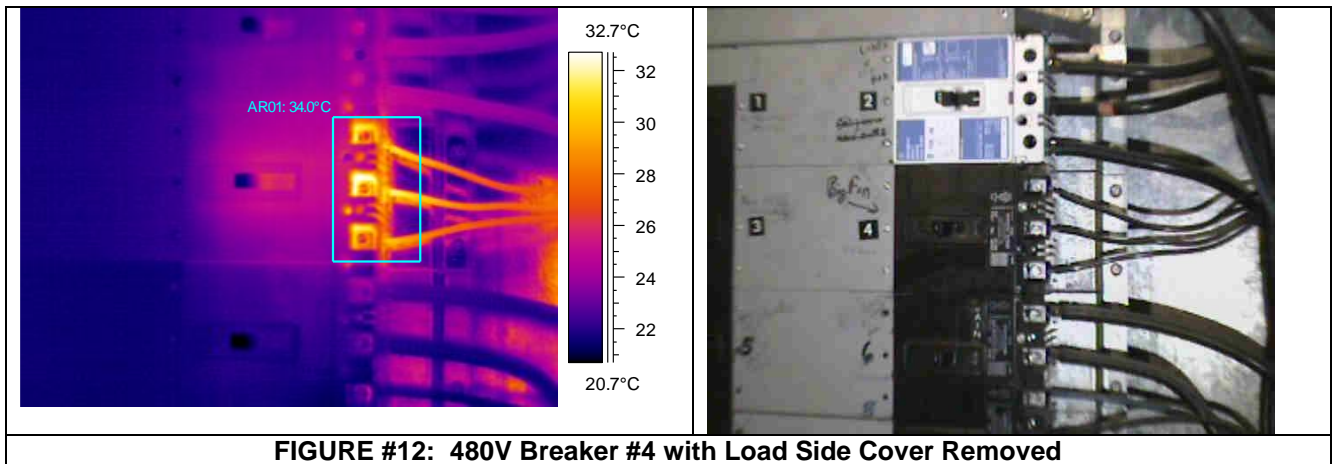
This image (figure #12) shows that the contact temperature was about 10°C higher than what was shown on the surface of the breaker. Also, NO anomaly was shown on the outside of the cover itself. We decided to remove the buss side cover to investigate the other side.

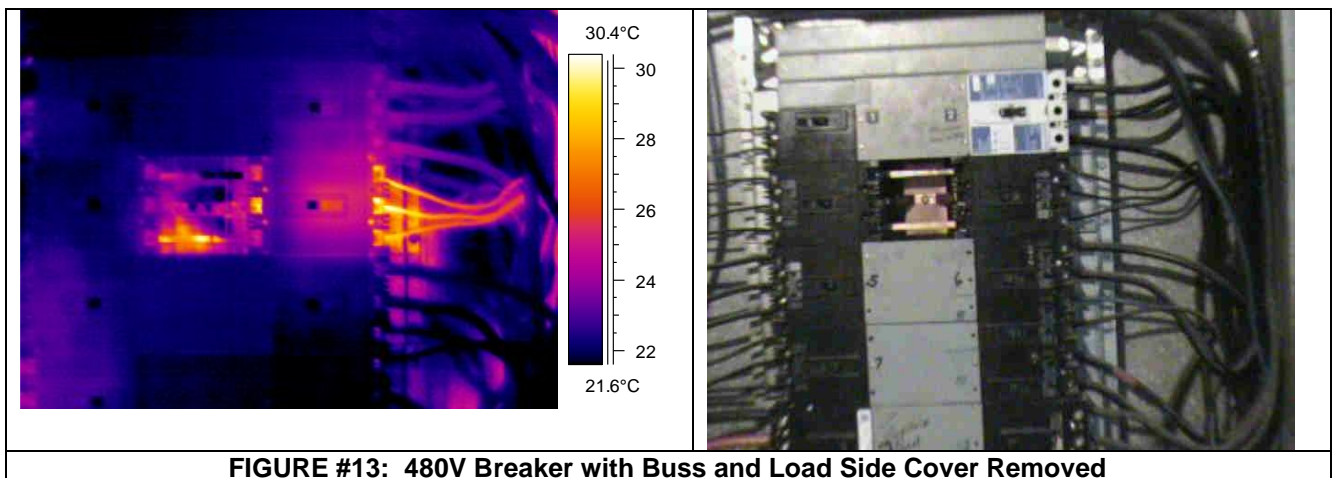
With the load side cover removed (figure #13), we noted a slight rise on the middle phase connection. The “issue” on the bottom phase buss was a reflection, but the connection was a true hot spot. It was at this point that we used our other tools available to get a voltage drop across the different connections and breaker contacts to determine where our issue was emanating from. With over a .275-millivolt drop across the B-phase contact of the breaker itself, we determined that breaker #4 was in need of replacement.

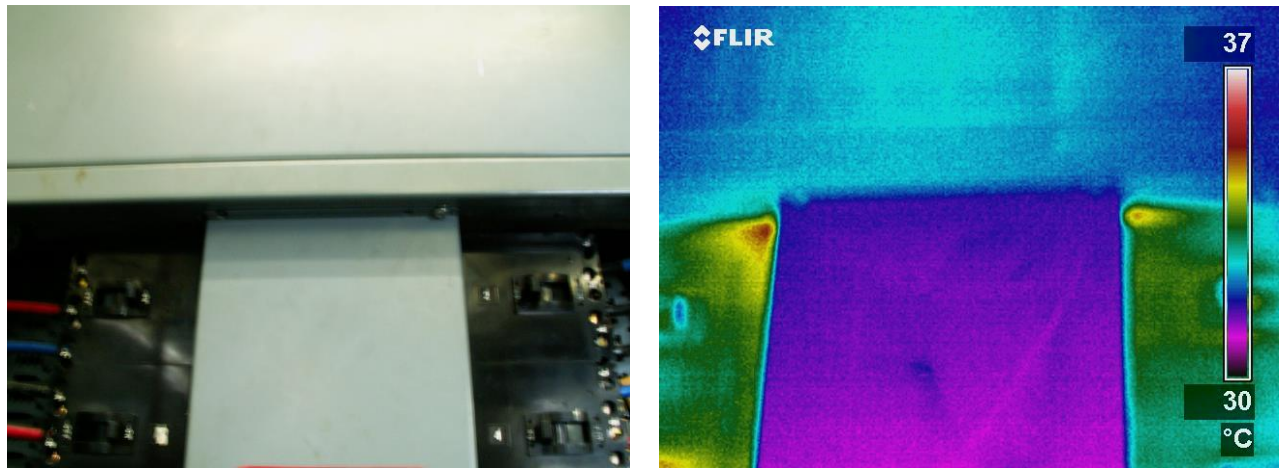
FIGURE #14

In one final example at a Medical Treatment Center in Fairbanks, Alaska, a Square D I-Line Panel rated at 800 amps was our target. Prior to performing any maintenance on the equipment, the customary Ultrasonic Airborne Safety Scan was performed and no anomalies were detected. As an additive safety precaution, we also conducted a brief IR scan with the camera on the exterior of the panel. The Digital and Infrared images are illustrated below in Figure #14:

As indicated in the images, there is no alarming thermal patterns in either the dead front cover (around 30 Degrees C) or main lug access cover. Some indications at the top corner of the dead front do illustrate some energy, but this could be merely load related heating effects. Once the dead front cover is removed, it is a bit more apparent that there is some type of heating occurring near the top of the panel and indicated in Figure #15 below:

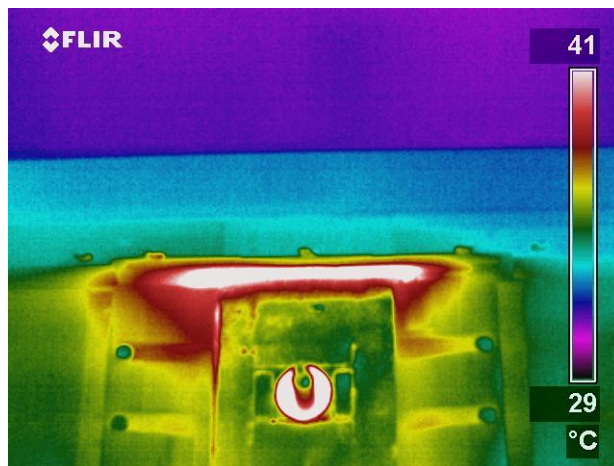
FIGURE #15

The image above certainly illustrates that there is something suspect within the panel (Now the temperature is around 42 Degrees C); however, it is still not conclusive as to the source or the severity of the condition contributing to the thermal emission we are observing. Once the top main lug access cover is removed for inspection, it becomes reasonably clear that there is a deficiency on the main lug connections illustrated in Figure #16, but where and which one(s)?

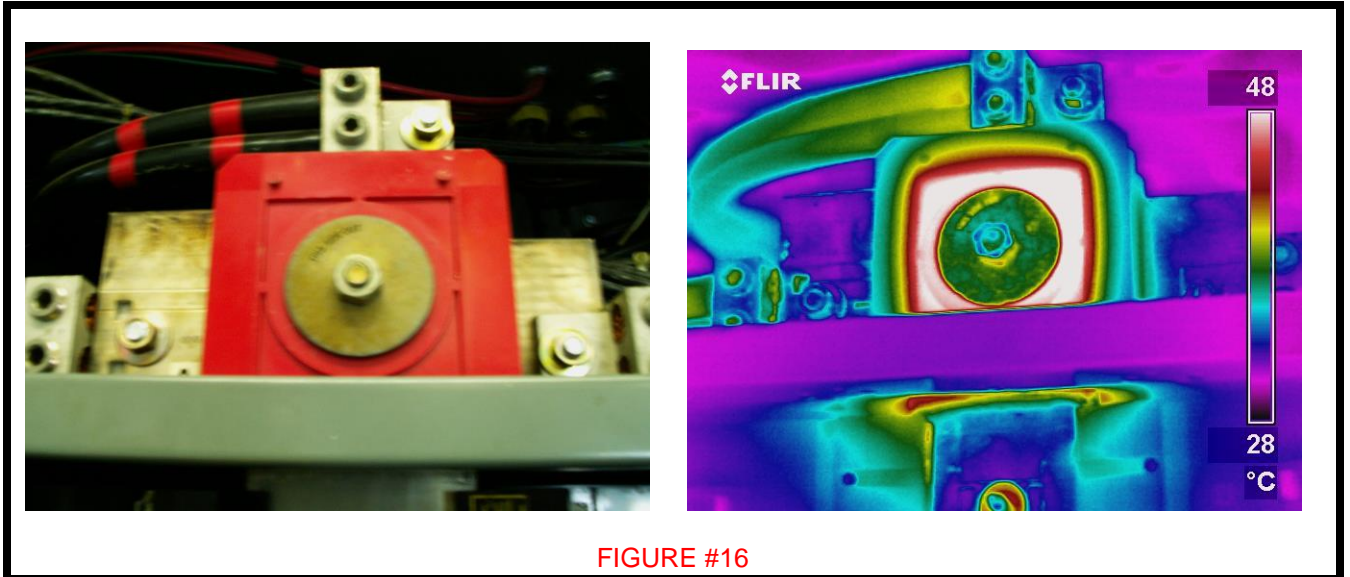
FIGURE #16

Even without the implementation of complete analysis procedures, it is evident that the problem is centered on the main lug assembly and the problem temperature is actually 53 Degrees C. This is nearly a 22 Degree C error in temperature with the covers on and with them removed. Additionally, terminations are rated at 65 Degrees C absolute and this 800 Amp panel had balanced loads of 450-460 amps, only 50% of its rated capacity, and not all of the customers loads were in use at the time of the visit.

Once these additional loads are added, the problem temperature will then begin to increase exponentially and it won't be long before it will exceed the 65 Degree C rating of the lugs and cause them to rapidly deteriorate and ultimately fail, possibly causing a fire and damage to other components.

Once this evidence was presented to the customer immediately while on site, authorization to perform the repairs was secured for 12:00 AM that evening. The panel was deenergised, the main lugs were disassembled, inspected, cleaned with emery cloth, new hardware was used to reinstall it, the toggle bolt was torqued to Square D's specifications, and the panel was returned to service.

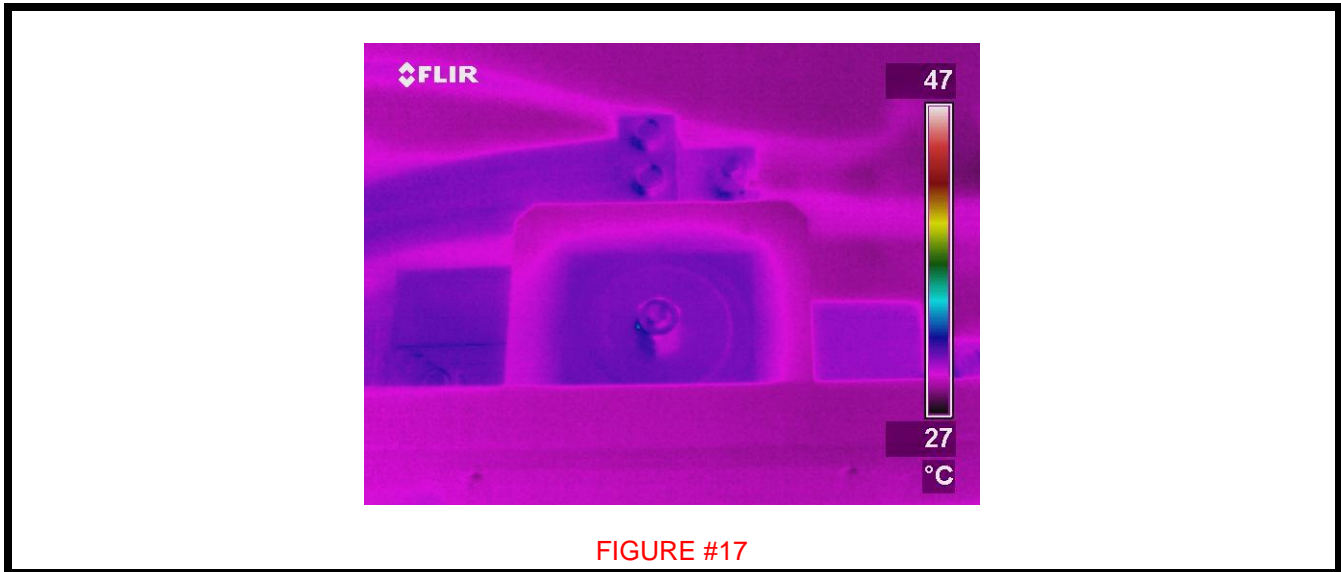
FIGURE #17

In this case, you can see below in Figure #17, they were extremely successful when returned to service and under the same operating conditions, the "problem" temperature was reduced by nearly 25 Degrees C and well within acceptable operating parameters.
