# **Infrared Inspections on Electric Panels without Removing Covers: Can the Inspection be Completed Correctly?**

*Joe Gierlach Director Technical Training and Support TEGG Corporation  
Joe DeMonte Senior Thermography Course Instructor*

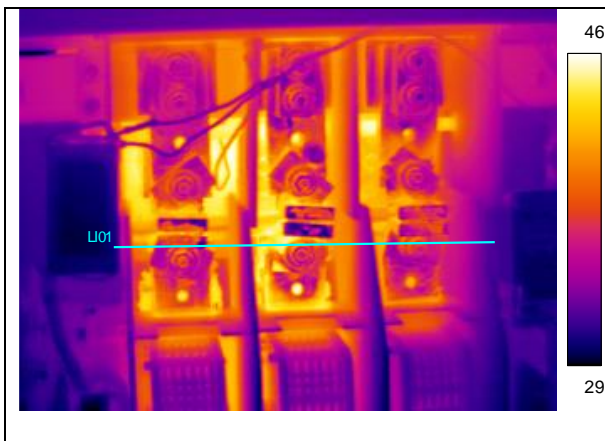
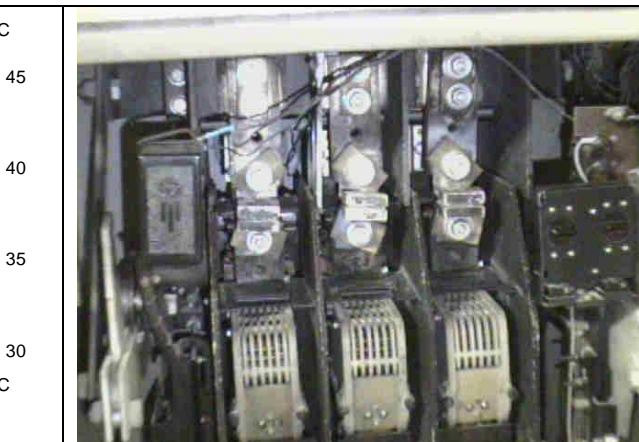
**FIGURE #6: Cabinet 691**

Consider the infrared and visual images shown in figures #5 and #6. Both show the 480V buss cabinet and connections associated with a 13.2KV to 480V step down transformer. The cabinet in figure #5 is running approximately 2°F warmer and shows considerable heat towards the top of the cabinet due to convective gains. This would seem to point to a potential issue in the 692 cabinet and no issue in the 691 cabinet. However, upon removal of each of the covers by approved safety measures, we scan with the IR camera again and find the images to be opposite of what we originally thought.

The cause of the heat on the warmer 692 cabinet was load related. Cabinet 691 actually had an anomaly that would have gone undetected by not properly removing the cover during the inspection. Also, the fact that this anomaly was found at approximately 10% of the system's rated load shows how a fairly important problem could have been overlooked. Once the load is increased, the heat generated by the fault will increase exponentially. Our calculations would have this rise increase to approximately 110°C when the transformer was under 80% load.
